# THE BRUNNER MINE

## INDUSTRIAL SITE

# Visitor Guide

# Brunner, 1864 — 1942

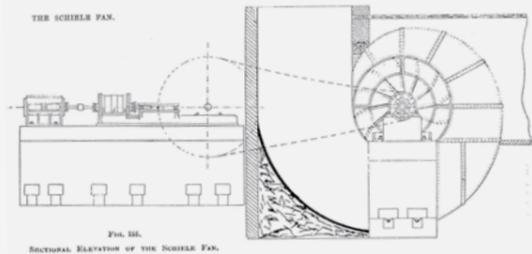
The foundation remnants in view once housed a powerful high speed Schiele extractor fan, responsible for drawing an air current through the mine workings. This 9 foot 6 inch (2.9m) fan, installed in 1888, was driven by a steam engine (located right of the tunnel) and was capable of displacing 16000-18000 cubic feet of air per minute.

The main mine entrance tunnel (previously located to the left) acted as the fresh air intake. Air was directed through the myriad of mine tunnels to the working faces via canvas screens known as brattice. These helped separate the good air from the foul air which was then coursed back to the surface via the brick lined 'return airway' tunnel in front of you.

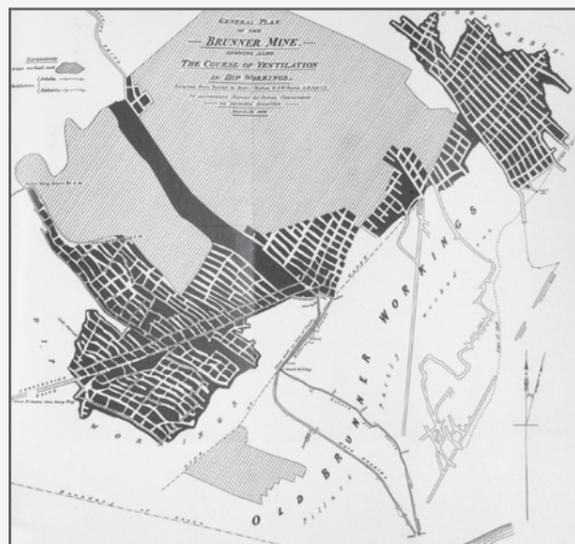
Plan of 1896, showing the ventilation system in the Dip workings of the Brunner mine which was dependant on the schiele fan. Part of the Royal Commission of enquiry report on the Brunner Mine Disaster, 1896.

The intake and return airway ran parallel underground for about one kilometre before hitting the fault line. The ventilation system continued down into the dip workings – the area where the miners met their death on the day of the Brunner disaster.

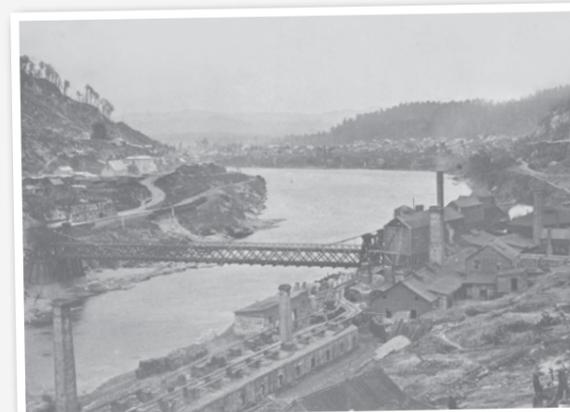
A view of the coke ovens and brick works with mine bins beyond, c. 1890.

Note the remains of the ganister rock façade that once surrounded the whole coke complex and helped insulate the ovens, in effect hiding the shapely brick domes. Initially, ovens were front loaded with coal slack but by 1883 they were being top loaded via a tramway viaduct overhead. The ovens on this side were the last 13 to be constructed (between 1889 and 1890) bringing the total to twenty five ovens.

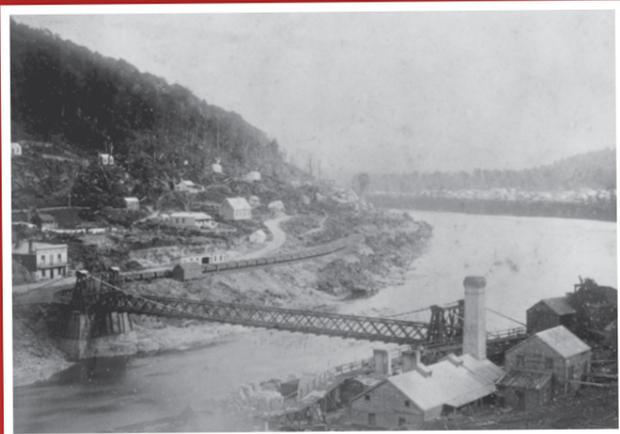
A view from the back of the fireclay works looking across to the railway yards, c. 1886.

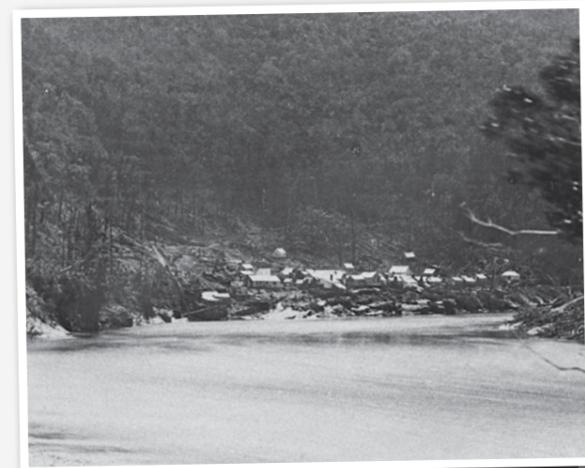
View of Brunner Town in 1870 just upstream from the mine, bins shoots and coke ovens (near the river edge centre of photo).  
Department of Conservation

The Nelson Coal Mining Company made up of Australian (Ballarat) investors initiated the coke industry at Brunner. These twin vaulted coke ovens, built in 1868, were made with fire bricks imported mostly from Melbourne.

Coal was trucked from the nearby mine entrance and about 4 tons were manually loaded through each arched opening. After the coal was set alight, the opening was bricked up leaving just a small amount of air. Gases escaped through rear flues. Two days later a few tons of coke was raked out and quenched with water before being bagged on a coke platform in front of the ovens.

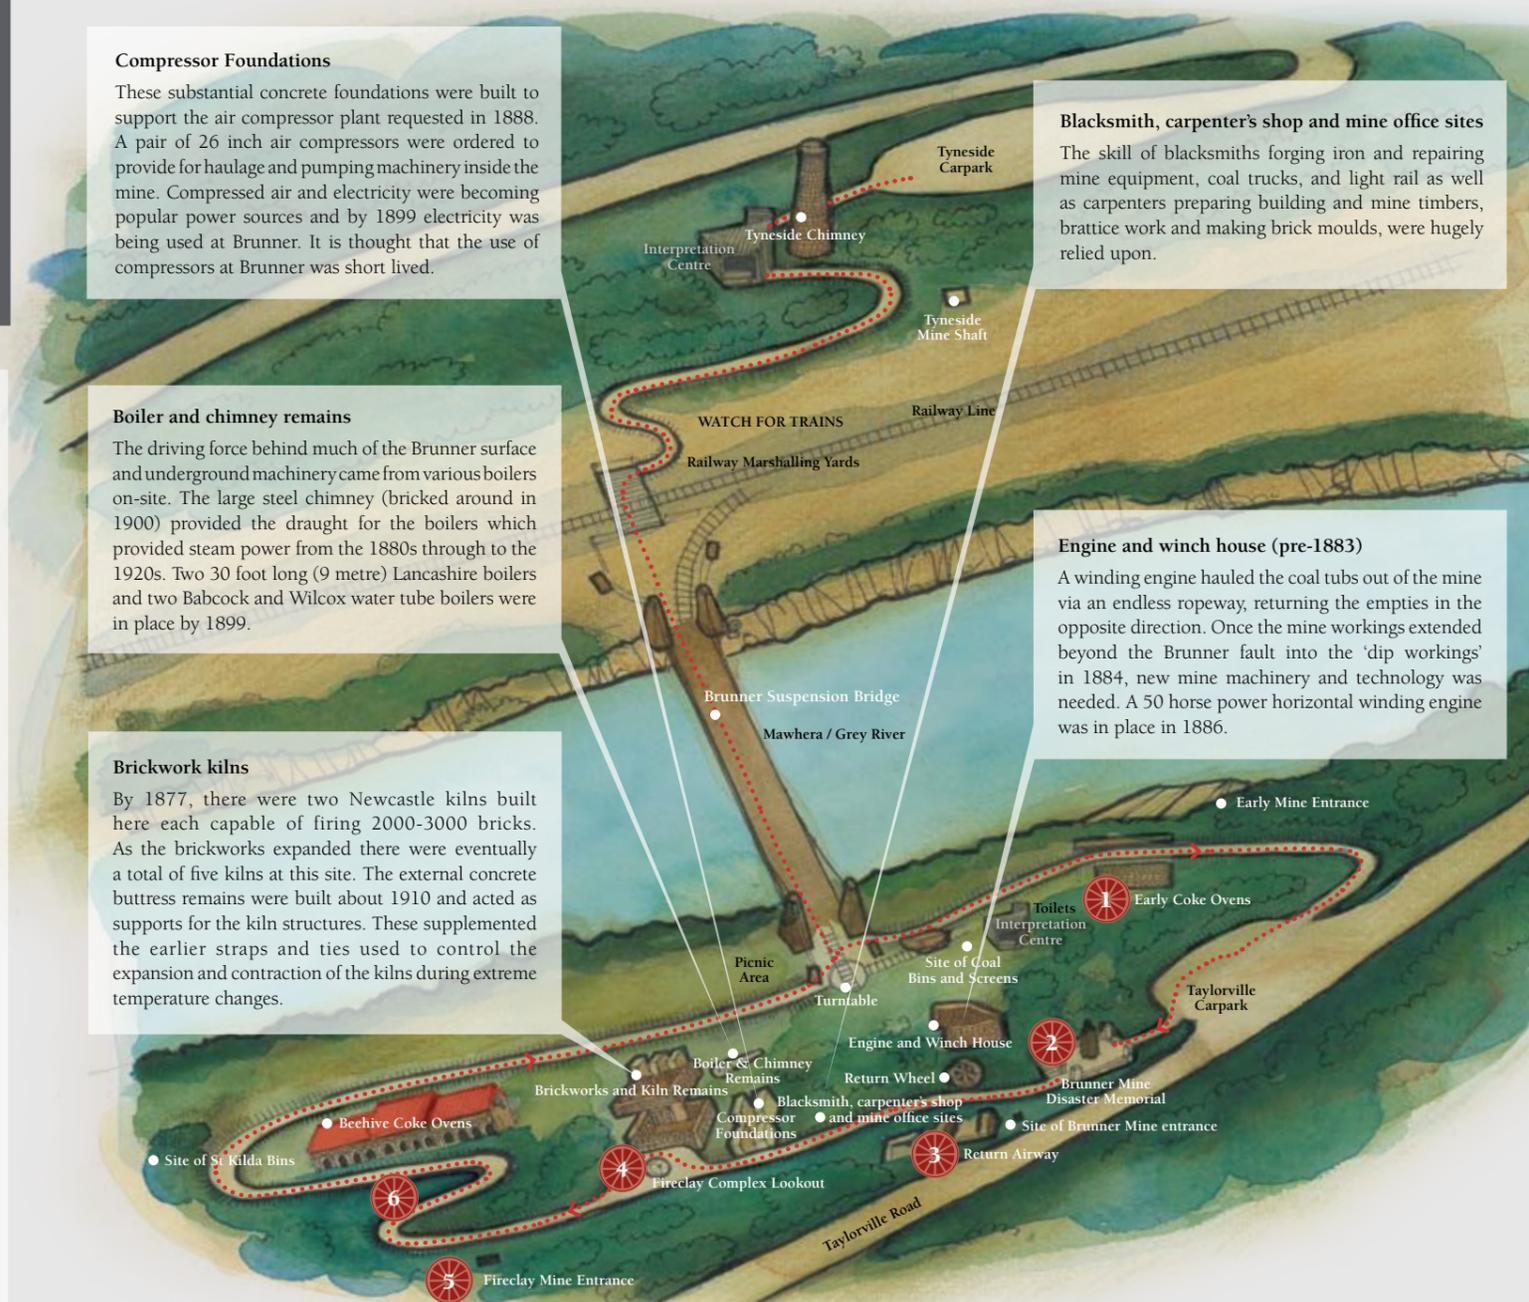
Illustration: Rachel Hirabayashi

These substantial concrete foundations were built to support the air compressor plant requested in 1888. A pair of 26 inch air compressors were ordered to provide for haulage and pumping machinery inside the mine. Compressed air and electricity were becoming popular power sources and by 1899 electricity was being used at Brunner. It is thought that the use of compressors at Brunner was short lived.

The driving force behind much of the Brunner surface and underground machinery came from various boilers on-site. The large steel chimney (bricked around in 1900) provided the draught for the boilers which provided steam power from the 1880s through to the 1920s. Two 30 foot long (9 metre) Lancashire boilers and two Babcock and Wilcox water tube boilers were in place by 1899.

By 1877, there were two Newcastle kilns built here each capable of firing 2000-3000 bricks. As the brickworks expanded there were eventually a total of five kilns at this site. The external concrete buttress remains were built about 1910 and acted as supports for the kiln structures. These supplemented the earlier straps and ties used to control the expansion and contraction of the kilns during extreme temperature changes.

A winding engine hauled the coal tubs out of the mine via an endless ropeway, returning the empties in the opposite direction. Once the mine workings extended beyond the Brunner fault into the 'dip workings' in 1884, new mine machinery and technology was needed. A 50 horse power horizontal winding engine was in place in 1886.
